Manhole Inspection Summary

Manhole # S15AA2014MH

Insp Date: **7/24/08 11:02 AM**

Location Address: **CARTERDALE RD**

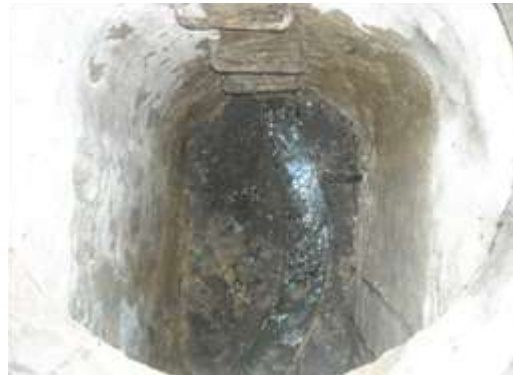
Top View

Corroded steps. Evidence of surcharge - Bench debris. Channel debris.

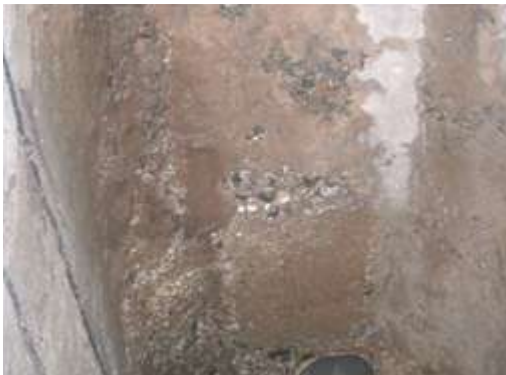
Defect

Corbel deterioration and infiltration.

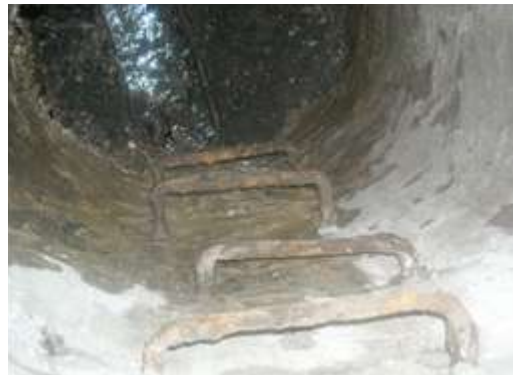
Defect

Corroded steps.

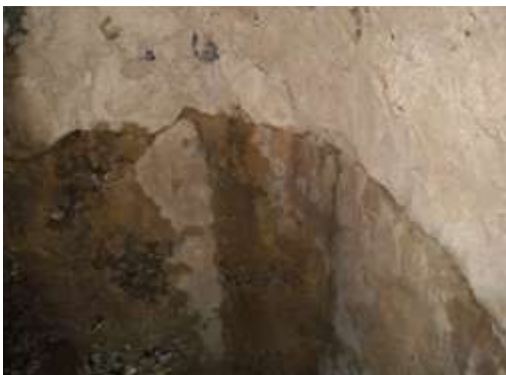
Defect

Corbel infiltration.

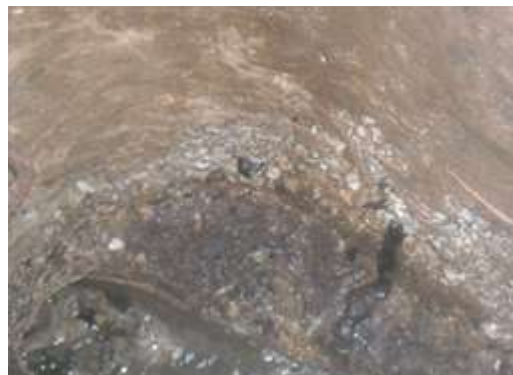
Defect

Barrel deterioration.

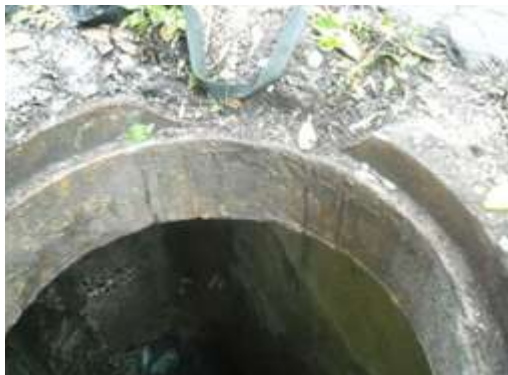
Defect

Broken frame. Frame leaks. Corbel and Barrel infiltration.

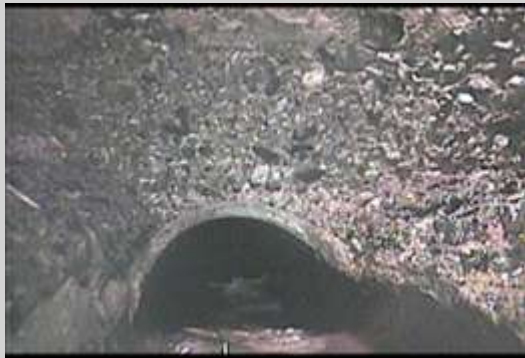
8 in. Circular Gravity Sewer Pipe Out @ 12 O'Clock

Deposits: ☐ None ☒ **Mud** ☐ Sludge ☒ **Debris** ☐ Grease

Silt Depth: **1** (in.) Deposits Extent: **Light**

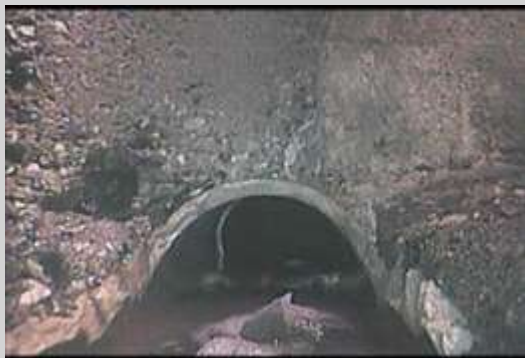
8 in. Circular Gravity Sewer Pipe In @ 7 O'Clock

Deposits: ☐ None ☒ **Mud** ☐ Sludge ☒ **Debris** ☐ Grease

Silt Depth: **2** (in.) Deposits Extent: **Light**

Infiltration: **None** Pipe Seal Cond: **Broken**
